A Long Term Study on the Performance of Early Streamer Emission Air Terminals in a High Keraunic Region

Z. A. Hartono and I. Robiah

Abstract – The very high keraunic level in Malaysia makes it an ideal location for the field testing of lightning air terminals. The widespread use of the early streamer emission (ESE) air terminals enabled their performance to be studied under real lightning conditions. Lightning strike damage data that would have taken decades to collect in low keraunic regions can be done in a few years only. Using a lightning interception prediction method that was developed by the authors, it was possible to obtain pre-strike and post-strike photographs of the affected buildings. The failure of the ESE air terminals to intercept nearby lightning strikes posed an unacceptable risk to public safety. An earlier version of this study had been submitted to the National Fire Protection Association (USA) in 1999 as part of a review on the efficacy of the ESE air terminals.

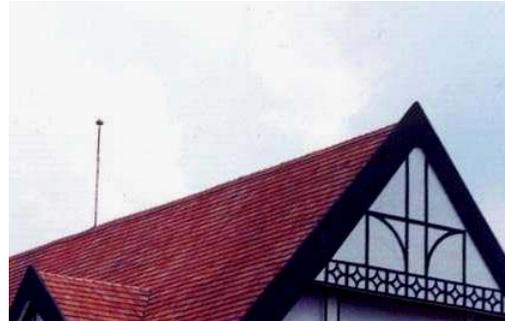
This building was installed with an Australian made ESE air terminal mounted on a 5m pole in 1998 (Figure 1). The main roof is approximately 40m long with the air terminal installed in the middle according to the Collection Volume Method (CVM) design.

Figure 1: A photograph of the RSC building taken in 1998. The building was installed with an Australian made ESE air terminal

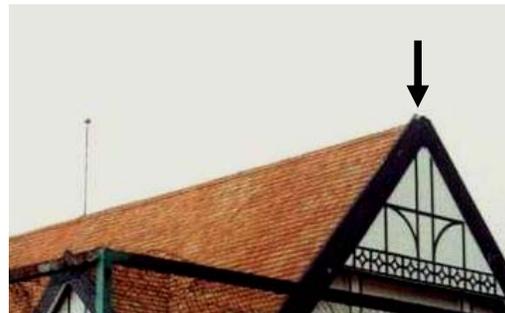
Although the air terminal is claimed to have a protective range exceeding 50m, lightning reportedly

struck and damaged the façade which was about 20m away (Figure 2).

Figure 2: A photograph of the RSC building taken in 2001. The building had been struck and damaged by lightning as can be seen on the right.

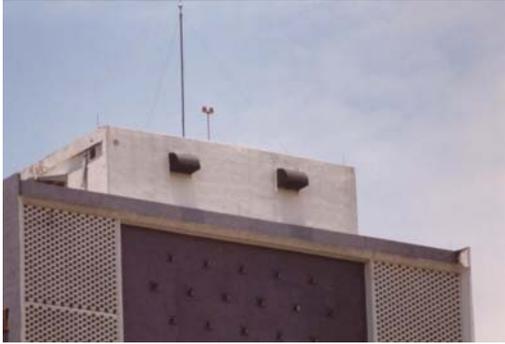
This government administrative building was installed with a French made ESE air terminal mounted on a 5m guyed pole in 1999. The building was also installed with the Franklin rods but they were located about 0.5m away from the corners of the building (Figure 3).

Figure 3: A photograph of the Wisma Tanah building taken in 2000. The building was installed with a French made ESE air terminal.

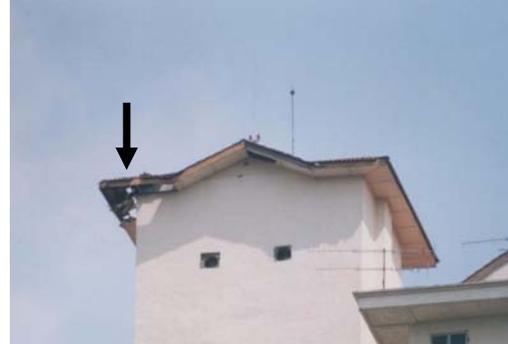
Figure 6: A photograph of the other Setapak Ria apartment building showing a different French made ESE air terminal and the stricken point.

A recent survey shows that the buildings had been struck several times by lightning. A close inspection shows that some of the stricken points had occurred on the same roof where the air terminals were located (Figures 5 and 6).

In these cases, the stricken points had come to within 10m of the air terminals that were installed at the center of the roof.

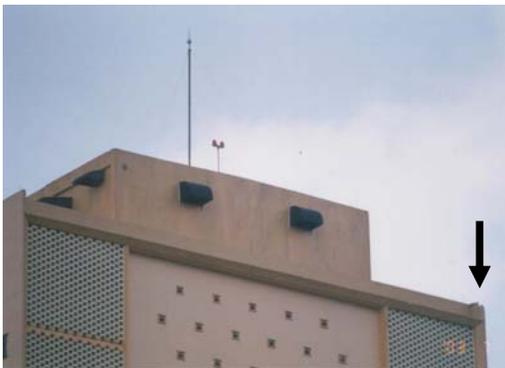
In 2003, the building was observed to have been struck by lightning on the corner of the building that was about 10m away and about 8m below the air terminal (Figure 4).

Figure 4: A photograph of the Wisma Tanah building taken in 2003. The building had been struck by lightning as can be seen on the right.

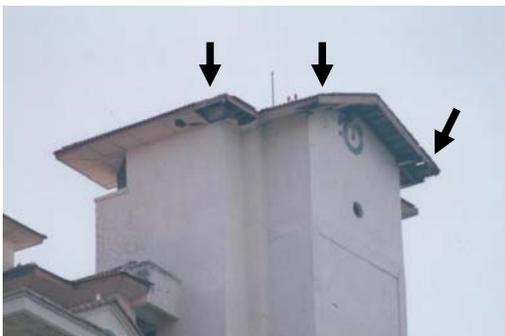
Figure 5: A photograph of one of the Setapak Ria apartment building showing the French made ESE air terminal and the stricken points.

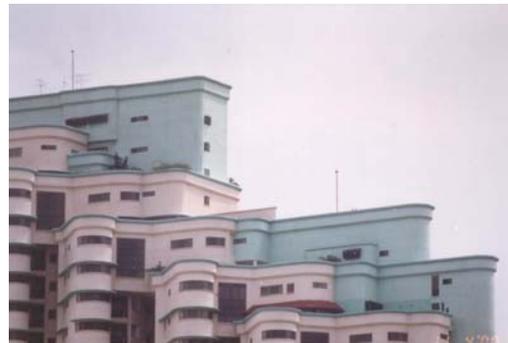
These 170m high split-level conjoined buildings were installed with the Australian made ESE air terminals mounted on 5m poles. One air terminal was installed per apartment building and they were centrally located on the roof (Figure 7).

The taller apartment block has a square-shaped concrete upper roof structure with rounded corners while the lower apartment block has a semi-circular middle and lower roof structures. According to the ESE manufacturer, these roof structures have much lower field intensification by virtue of their shapes and hence a lower risk of lightning interception.

Figure 7: Photograph of the Villa Putri apartment showing the two Australian made ESE air terminals installed on the split-level roofs.

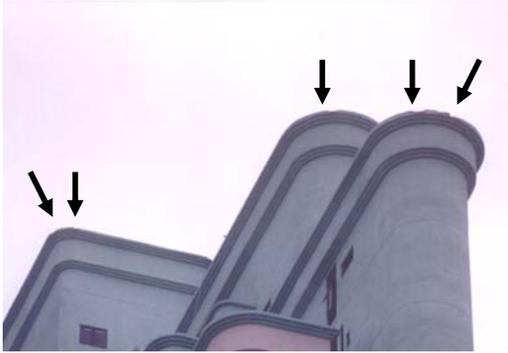
Figure 8: A close-up photograph of the apartment showing some of the multiple stricken points that have accumulated in the five year period since the building was installed with the ESE air terminals.

However, within a five year period, it was observed that seven stricken points had occurred on the rounded edges of the upper, middle and lower roofs. These stricken points clearly show that the enhanced protection claimed by the manufacturer was non-existent (Figure 8).

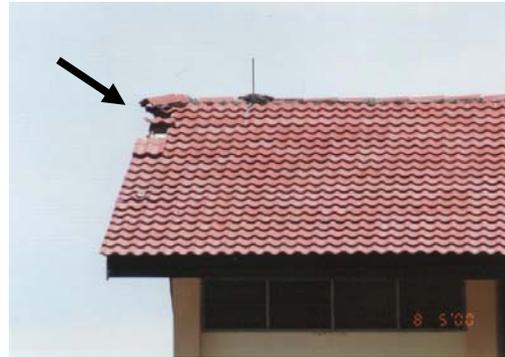
These buildings have been installed with the conventional system but the Franklin air terminals and conductors were not positioned at the known high risk locations i.e. at the ridge ends and edges of the gable roof.

As expected, the stricken points occurred at the predicted locations (Figures 9 and 10). The failure of

the Franklin rods to intercept the lightning stroke has more to do with erroneous positions of the rods rather than the rods themselves.

Figure 9: Photograph of a stricken point at the gable roof ridge end. The Franklin rod should have been installed right on top of the ridge end instead of about 1m away from it.

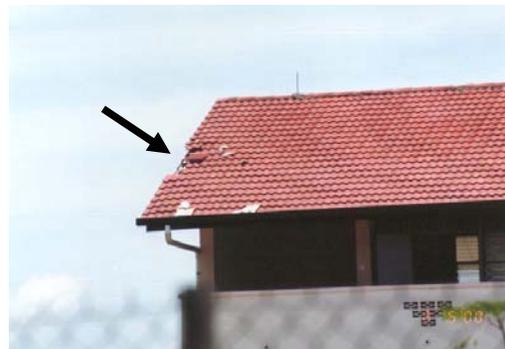
Figure 10: Photograph of a stricken point on the slanting edge of the gable roof. The air terminal conductor should also be installed on the edges of the gable roof.

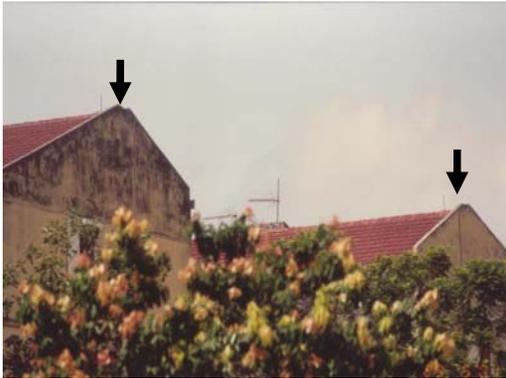
Similar to the school buildings mentioned above, the Franklin rods were not positioned at the known high risk locations. Since these buildings have been built more than a decade ago, many of the apartment blocks had been struck by lightning at almost the exact same location i.e. at the ridge ends of the gable roof. In some cases, adjacent blocks of apartment display similar stricken points (Figures 11 and 12).

Figure 11: Photograph of two adjacent blocks of apartment showing similar stricken points. In both cases, the Franklin rods were installed just 0.5m away from the ends.

These damages could have been prevented if the Franklin rods had been installed right on top of the ridge ends. In this way, the recommendations mentioned in the draft Australian/New Zealand standard represent a significant step towards a more effective application of the conventional air terminal and should be seriously considered.

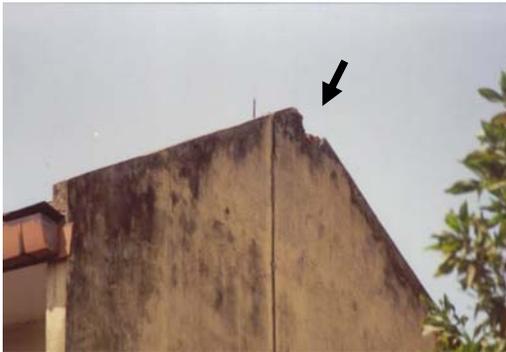
Figure 12: A close-up photograph of another apartment block showing the stricken point and the Franklin rod beside it. For effective protection, the rod must be positioned right on the ridge ends and similar high risk locations.
