29th International Conference on Lightning Protection

PERFORMANCE OF NON-STANDARD LIGHTNING AIR TERMINALS: REVISITED

Z. A. Hartono
Lightning Research plc
zahartono@ieee.org
457 Jalan B11, Taman Melawati, 53100 Kuala Lumpur, Malaysia

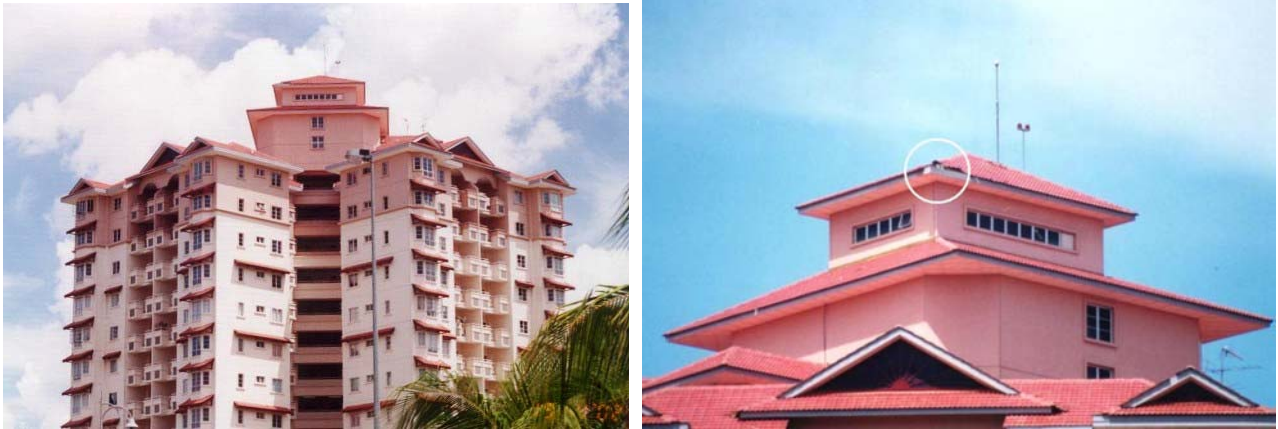
Since observations began nearly two decades ago, a growing number of bypasses have been observed on some of these roofs that were installed with air terminals that complied with either the NF C 17-102 [15] standard (Fig. 1), i.e.

the ESE manufacturing and installation standard published by the French ESE manufacturers, or the CVM (Fig. 2). The occurrences of bypasses were recorded on many structures protected by early streamer emission (ESE) or collection volume method (CVM) air terminals. These suggest that the NF C 17-102 standard and the collection volume method of air terminal placement are defective. Therefore, the ESE/CVM air terminals are not better than the Franklin rods.

Fig. 1 – A bypass occurred close to an ESE air terminal that is manufactured and positioned according to the NFC 17-102 standard.

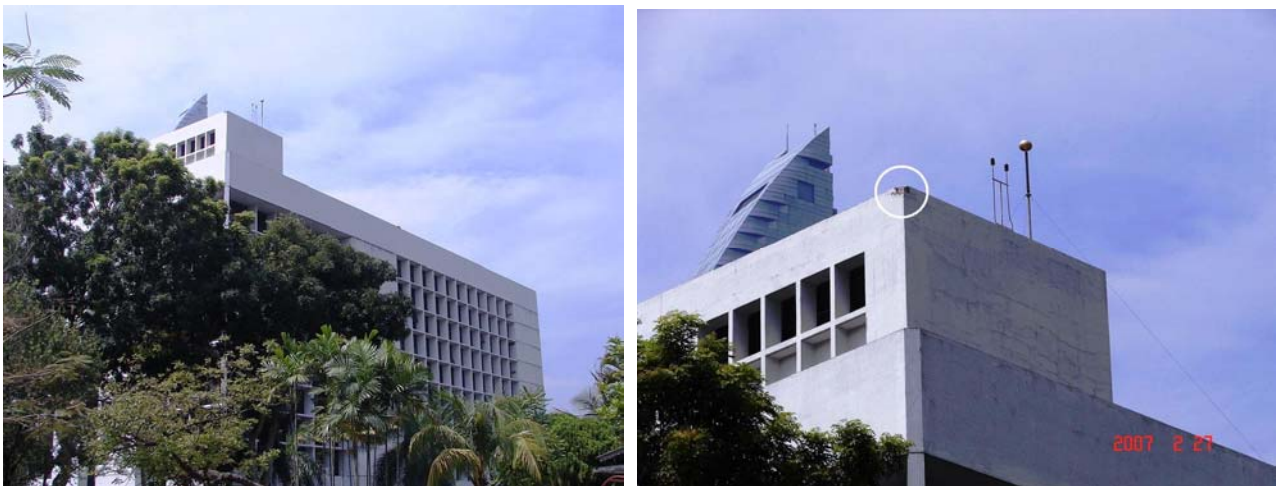
Fig. 2 – A bypass occurred close to a CVM air terminal that is positioned according to the proprietary collection volume method.

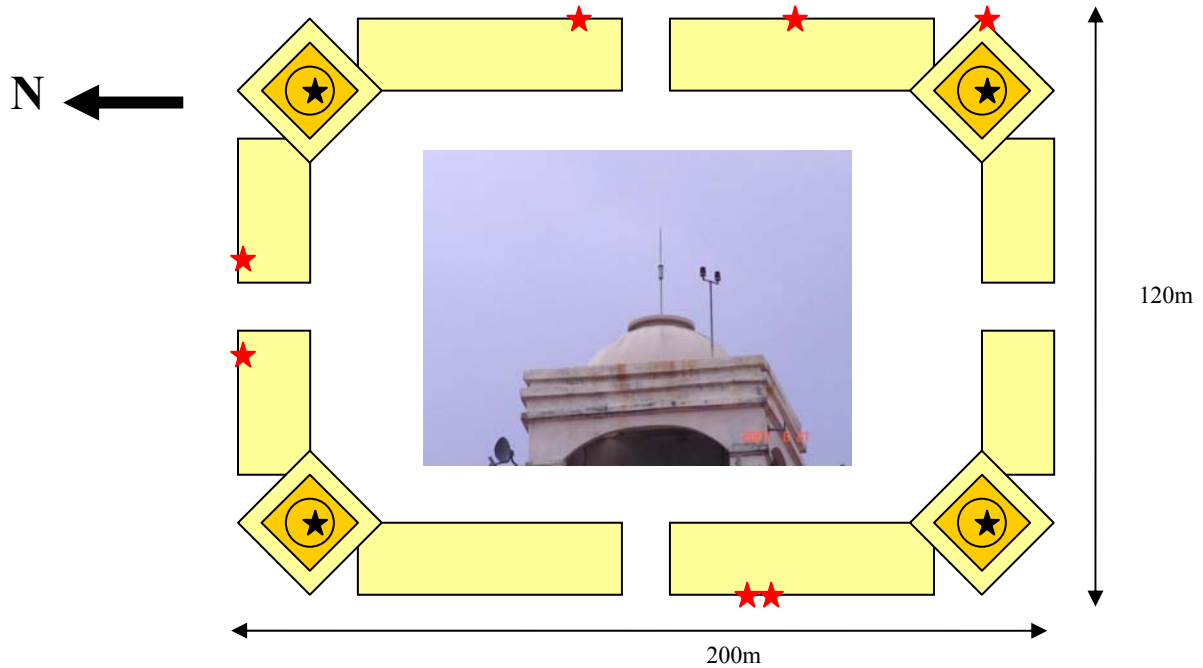
Since the apartment blocks were completed in 2004, seven bypasses have been observed (Fig. 3). Six of the bypasses occurred on the facades and corners in between two adjacent ESE air terminals while one bypass occurred on the corner of a tower block a few meters away from an air terminal.

This case study suggests that the use of multiple ESE air terminals to protect a large building have not prevented the occurrence of bypasses due to lightning. The study also suggests that the repositioning of the ESE air terminals towards the corners of the building have resulted in fewer occurrences of bypasses at these locations. This result is expected

Fig. 3 – A plan view of the Crimson Apartments. The black five-pointed stars indicate the positions of the ESE air terminals on the tower block while the red stars indicate the positions of the observed bypasses. The picture in the centre of the diagram shows one of the observation decks with an ESE air terminal installed on it.

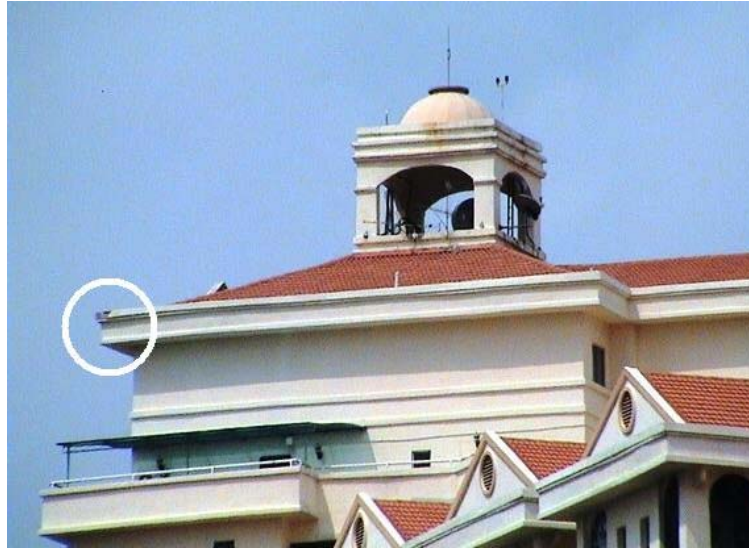
Fig. 5 – The bypass that occurred at the corner of the South-East tower block. This bypass is similar to that shown in Figs. 1 and 2.

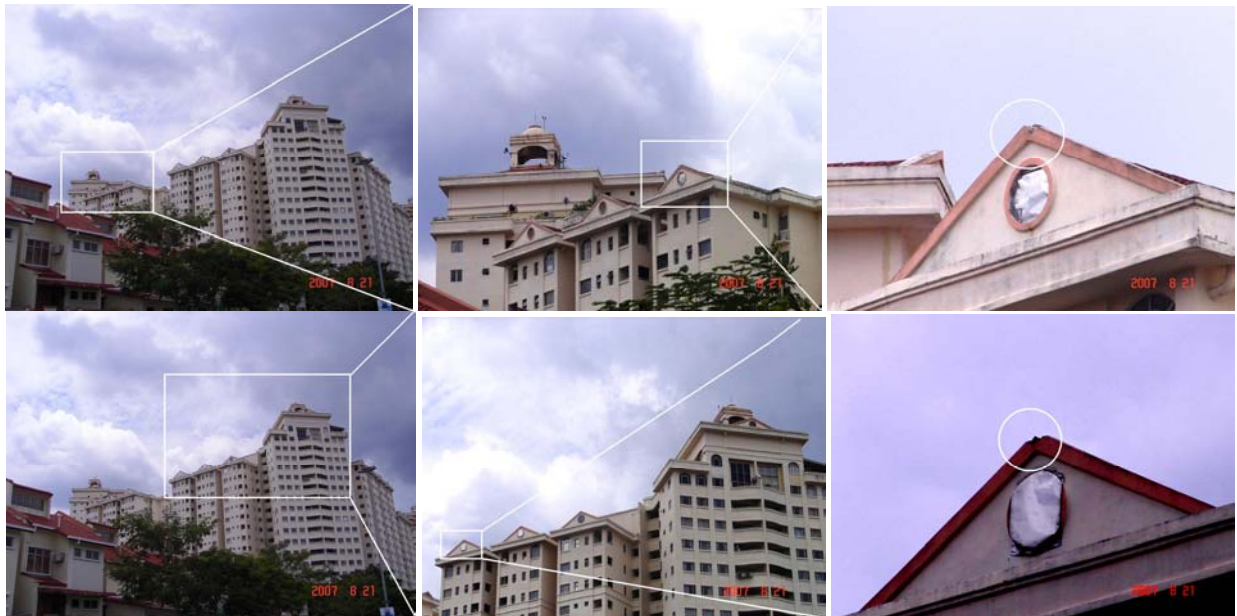
Fig. 6 – The two bypasses that occurred at the northern side of the Crimson Apartments.

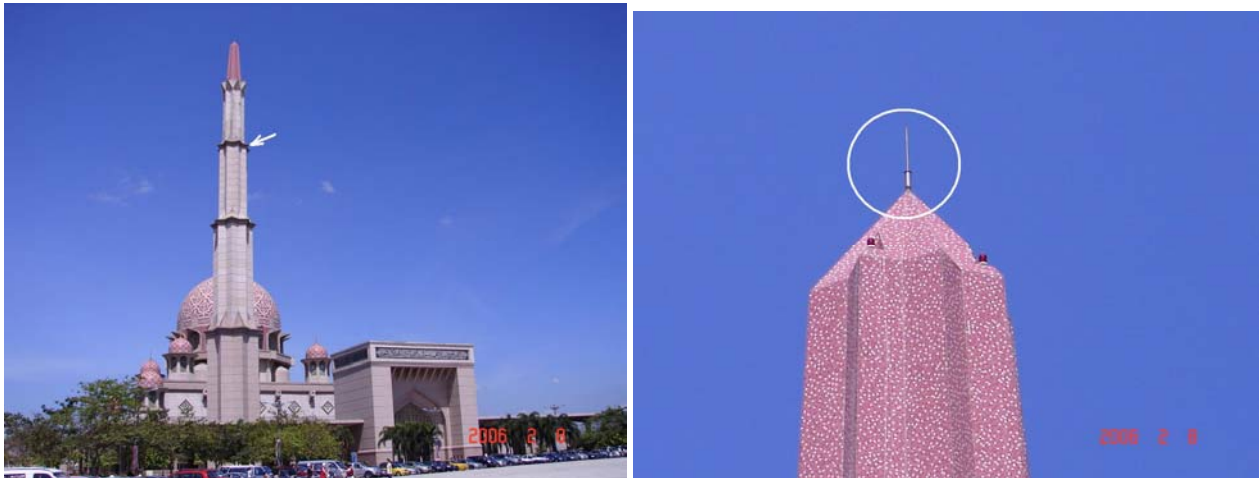
The minaret was struck by lightning and a bypass was observed on a protruding marble structure on the parapet wall of the minaret about 30 meters below the air terminal. Since the minaret has a radius of about 5m at the bypass location,

it is well within the air terminal's protection radius according to the NF C 17-102 standard. This suggests that the NF C 17-102 standard is defective even for applications to very slim structures such as a minaret.

Fig. 7 – The picture on the left shows the Putrajaya mosque and the position of the bypass (arrowed). The picture on the right is a close-up photo of the apex of the minaret and shows the ESE air terminal.

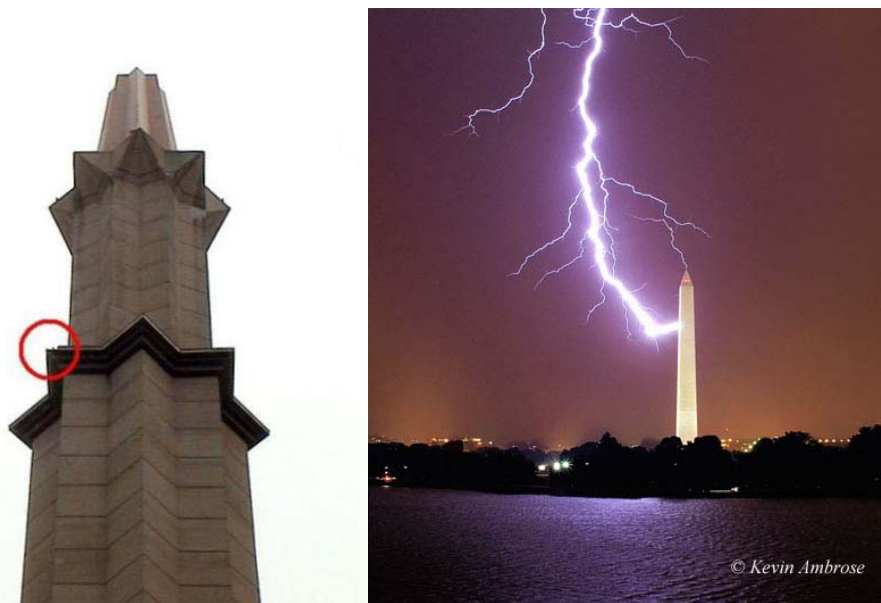
Fig. 8 – The photo on the left shows the location of the bypass on the minaret. The photo of the Washington Monument on the right shows how lightning might have struck the side of the Putrajaya minaret (Courtesy: Kevin Ambrose)

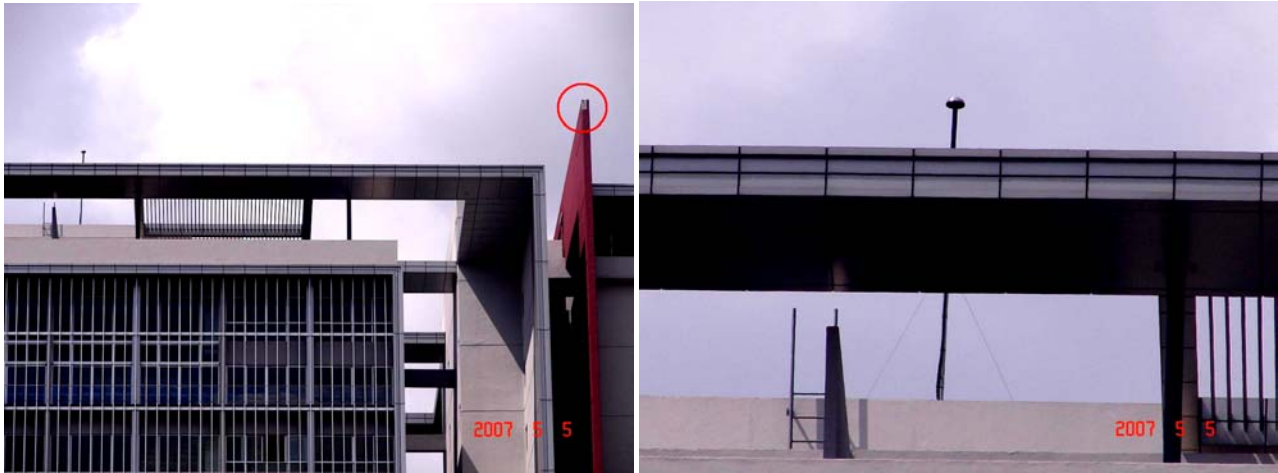
The claimed enhanced protection radius is doubtful since a bypass has been observed about 30m away from the new

CVM air terminal which was installed on the Dua Residency, a new residential high rise building in downtown Kuala Lumpur (Fig. 9). This bypass suggests that the new CVM air terminal is no better than the previous one at protecting buildings from lightning strikes and that the collection volume method is flawed. Incidentally, the bypass had occurred within six months of the new air terminal installation.

Fig. 9 – The bypass that occurred on the Dua Residency condominium (left). The new ESE air terminal (right) is positioned on the roof near the centre of the building about 30m away from where the bypass occurred.

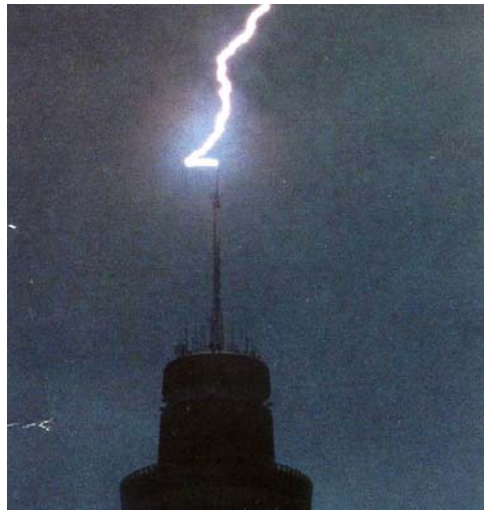
The first photograph (Fig. 11) showed a lightning flash intercepted by an ESE air terminal that was positioned according to the CVM. Mousa pointed out that the presence of a horizontal component of the return stroke attached to the ESE air terminal suggested that there was no early streamer formation. Had there been an early streamer formation, the initial return stroke path would have been in the upward direction and not horizontal as shown.

Fig. 11 – A photograph of the return stroke attached to a CVM air terminal (Courtesy: Global Lightning Technologies/Erico).

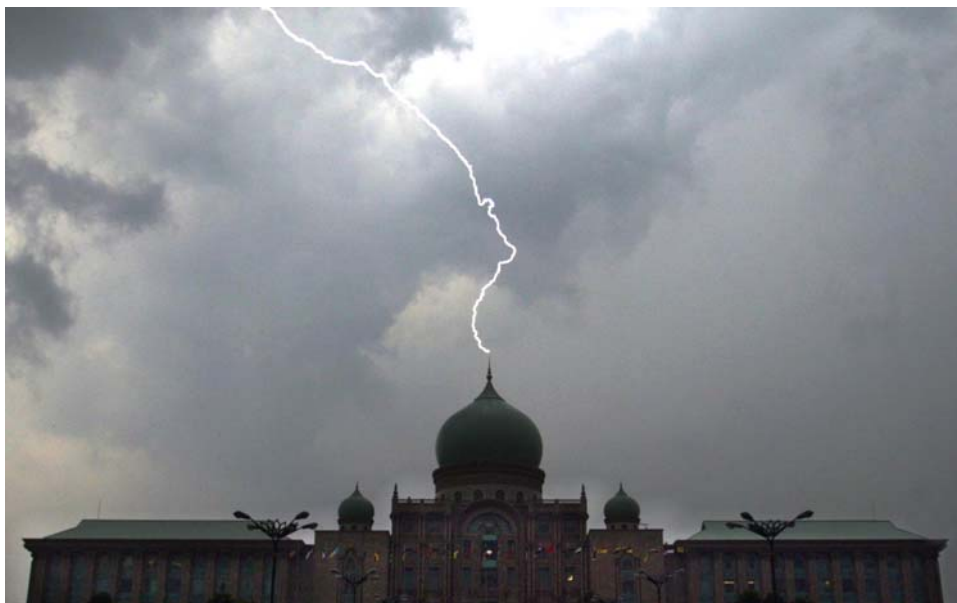
The second photograph (Fig. 12) showed a lightning return stroke intercepted by an ESE air terminal installed according to the NF C 17-102 standard. Similar to the previous photograph, there was no evidence to show that an early streamer formation had taken place from the air terminal since the initial return stroke emanating from the terminal was not in the direction of the downward leader and was non-linear.

Fig. 12 - A photograph of the return stroke attached to an ESE air terminal (Courtesy: The Star Publications, Malaysia).

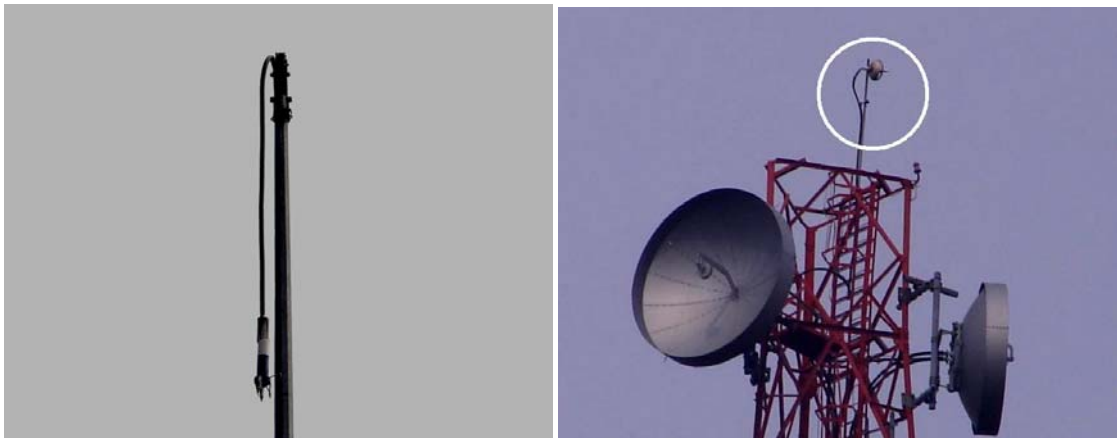
It has been observed that some of the mounting poles of the ESE/CVM air terminals, which were made from either fiberglass or fiber reinforced plastic, have been damaged as a result of lightning strikes. This suggests that the coaxial down conductors did not fully contain the current from the lightning flash.

Fig. 13 – Photographs showing the ESE (left) and CVM (right) air terminals hanging by their down conductors as a result of damages to their non-metallic mounting poles.
