29th International Conference on Lightning Protection

PERFORMANCE OF NON-STANDARD LIGHTNING AIR TERMINALS: REVISITED

Z. A. Hartono
Lightning Research plc
zahartono@ieee.org
457 Jalan B11, Taman Melawati, 53100 Kuala Lumpur, Malaysia

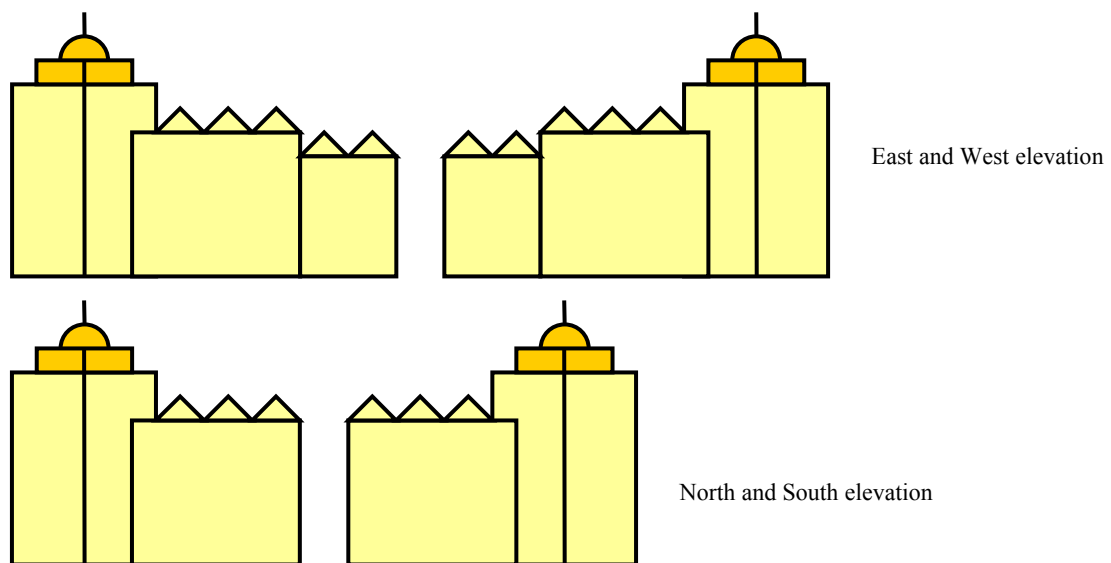
Since the apartment blocks were completed in 2004, seven bypasses have been observed (Fig. 3). Six of the bypasses occurred on the facades and corners in between two adjacent ESE air terminals while one bypass occurred on the corner of a tower block a few meters away from an air terminal.

Fig. 4 – Elevation diagrams of the Crimson Apartments.

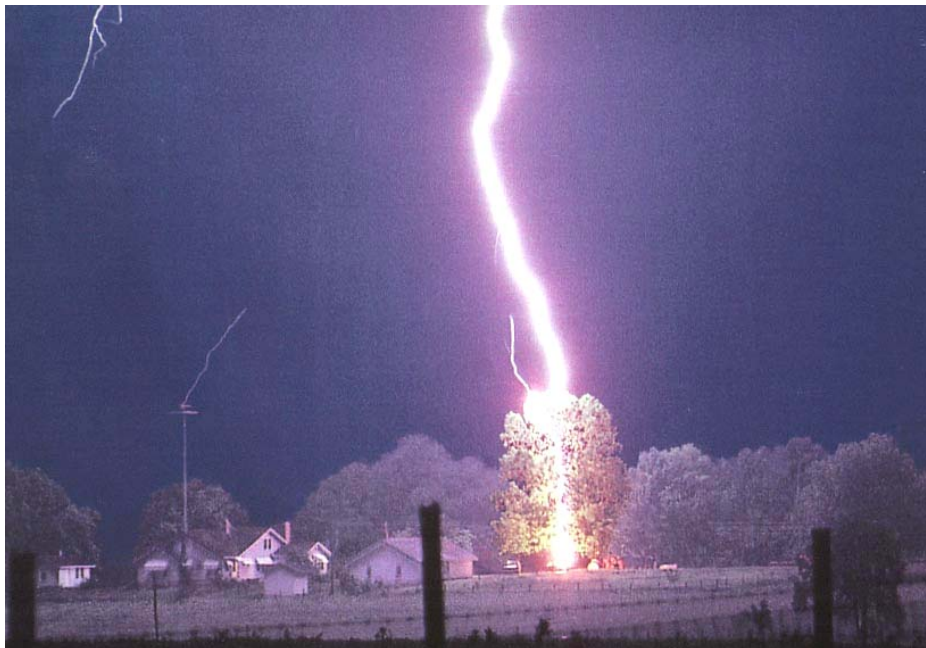
Photographs of streamers emitted by air terminals in laboratory experiments show the streamers moving upward in the direction of the high voltage discharge. In a well known 1993 photograph (Fig. 10) published by the National Geographic magazine, natural streamers emitted by grounded objects also move in the upward direction towards the downward leader. It is generally accepted that the path of the lightning return stroke follows the same path established when the upward streamer connects with the downward leader. Hence, Mousa had suggested that the “early streamer” from the ESE/CVM air terminals can be verified from the photograph of a return stroke intercepted by the terminal

Fig. 10 – A photograph showing streamers emitted in the upward direction by grounded objects. (Courtesy: National Geographic)
